# Repairs case study

Vattenfall UK operates Swinford Wind Farm, 11 x V90-2MW in rural Leicestershire. The site is operated by a small, dedicated team and uses a mixture of independent service providers to service and troubleshoot the wind turbines. This means that convenience, quick turnaround and efficiency are key to any minor component repairs operation. Vattenfall has also made commitments towards sustainability targets taking greater responsibility over waste streams from wind turbine operation.

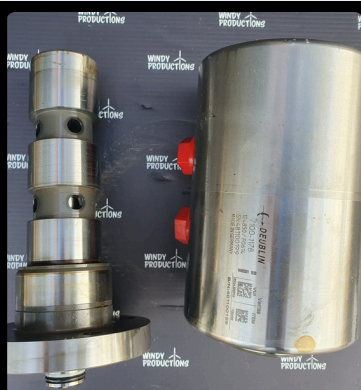
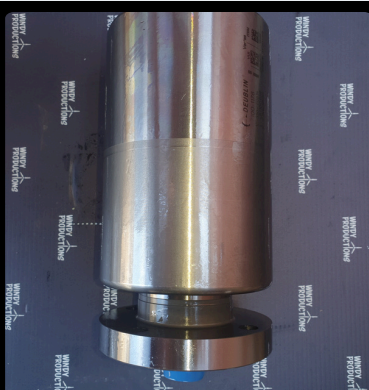
**before**

## Hydraulic Rotating Union

- Check tolerance of housing
- Re machine shaft
- Replace Seals

- Pressure test under rotation
- Leakage Rate
